Manhole Inspection Summary

Manhole # S29AA2010MH

Insp Date: **6/5/07 10:16 AM**

Location Address: **5500 CHARLES ST**

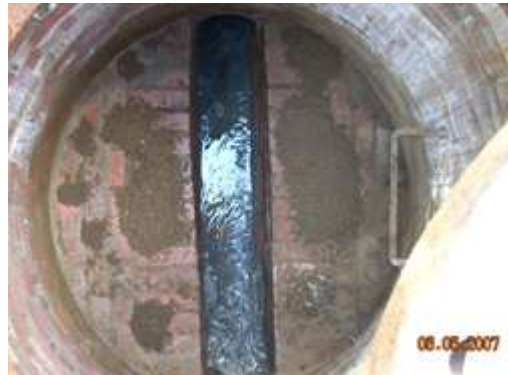
Top View

Bench and Channel debris.

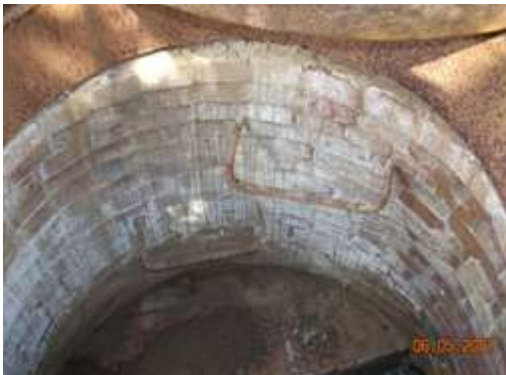
Defect

Frame Offset: **1** (in.)

Infiltration: ☐ None ☒ **Joint** ☐ Cracks ☐ Mortar ☐ Roots ☐ Wall

Infiltration: ☐ None ☐ Joint ☐ Cracks ☒ **Mortar** ☐ Roots ☒ **Wall**

Frame offset. Adjustment and Barrel infiltration.

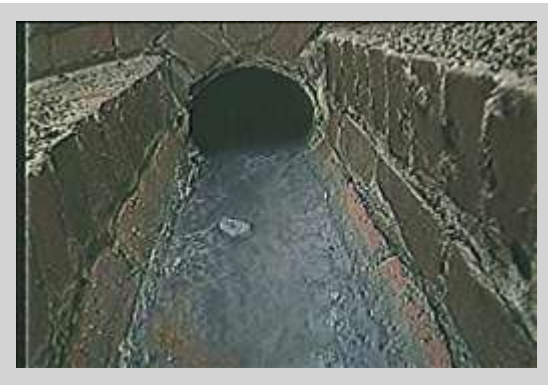
8 in. Circular Gravity Sewer Pipe Out @ 12 O'Clock

Channel deterioration.

Deposits: ☐ None ☐ Mud ☐ Gravel ☒ Debris ☒ Grease

Silt Depth: **0.5** (in.) Deposits Extent: **Light**

Infiltration: **Evidence** Pipe Seal Cond: **Unknown**

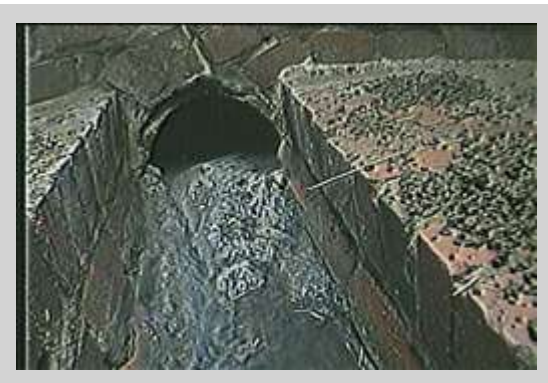
8 in. Circular Gravity Sewer Pipe In @ 6 O'Clock

Deposits: ☐ None ☐ Mud ☒ Gravel ☒ Debris ☐ Grease

Silt Depth: **1.5** (in.) Deposits Extent: **Light**

Infiltration: **Evidence** Pipe Seal Cond: **Broken**
